**Flood Control Project Maintenance
Levee Inspections**

Maintenance Issue Types Only, Levee Inspection Report By Mile - Spring 2017

Levee District No. 0003 (Glenn County)

Waterway	Bank	Unit Miles	Inspection Start/End	Inspector
Unit No. 01 Glenn County Sacramento River	Left	11.97	03/30/2017 03/30/2017	Bob Duffey

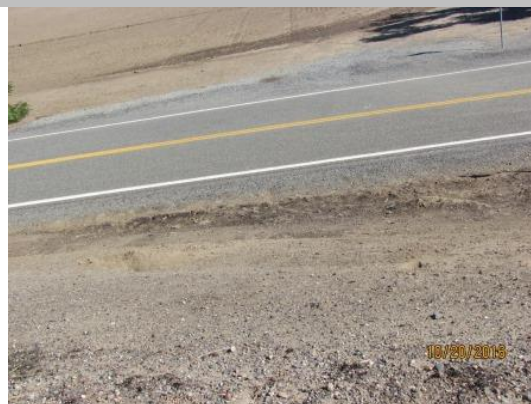
Photo 1 of 1 : SP_2017_LD0003_27_105_20170315_00059.jpg

LM Start	0.27	Rating **	M	Issue No.	105
LM End	0.27	Issue Type +	Ma	Location *	LS
Category	Earthen Levee		GPS Latitude/Longitude		
			Start	End	
Item	Animal Control		39.387413 °	39.387413 °	
			-121.991086 °	-121.991086 °	
DWR ID	DWR_LD0003_01_f_2016_105				
Comment Code					
A3 : No rodents visible, but rodent burrows visible; need to backfill and compact or grout burrows.					
Inspector Comment

View of the rodent holes along the landside slope.

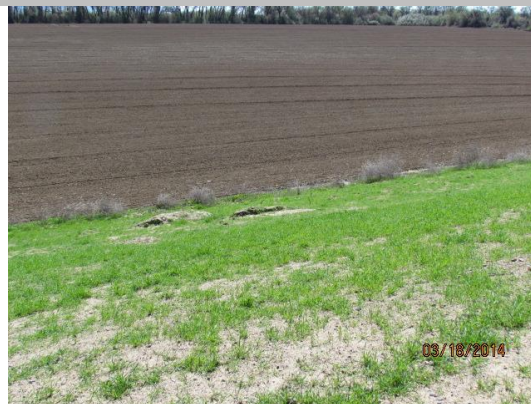
Photo 1 of 1 : SP_2017_LD0003_27_55_20170315_00030.jpg

View of the rodent activity along the waterside slope.

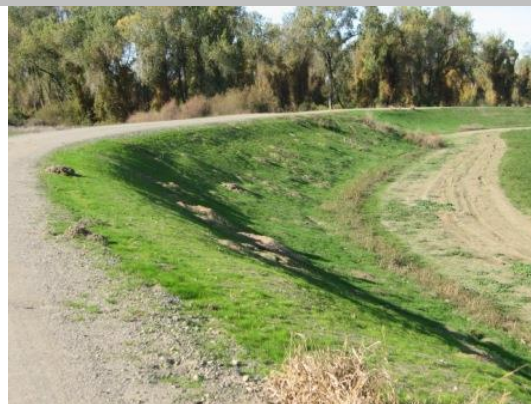
Photo 1 of 1 : SP_2017_LD0003_27_3_20170315_00001.jpg

LM Start	0.71	Rating **	U	Issue No.	3
LM End	0.77	Issue Type +	Ma	Location *	LS
Category	Earthen Levee			GPS Latitude/Longitude	
				Start	End
Item	Animal Control			39.388578 °	39.388410 °
				-121.997987 °	-121.998992 °
DWR ID	DWR_LD0003_01_s_2012_3				
Comment Code					
A3 : No rodents visible, but rodent burrows visible; need to backfill and compact or grout burrows.					
Inspector Comment

View of squirrel holes along the landside slope.

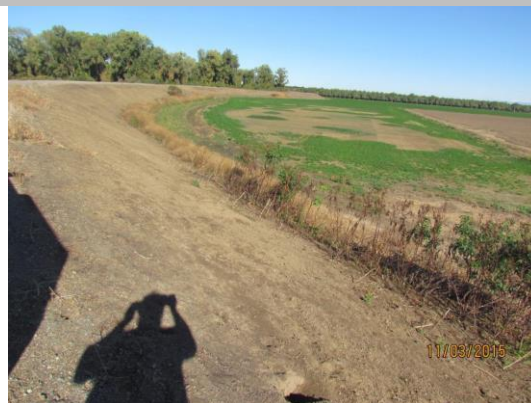
Photo 1 of 1 : SP_2017_LD0003_27_51_20170315_00028.jpg

View of the rodent holes along the landside slope.

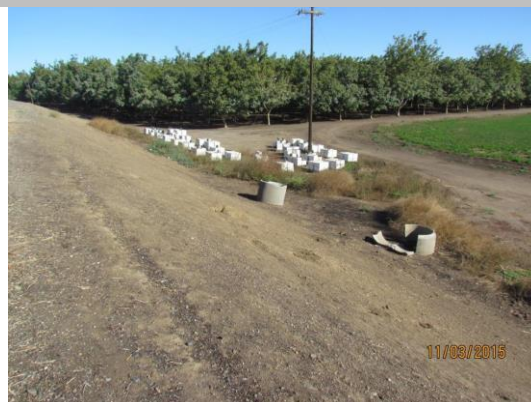
Photo 1 of 1 : SP_2017_LD0003_27_52_20170315_00029.jpg

LM Start	1.21	Rating **	M	Issue No.	52
LM End	1.21	Issue Type +	Ma	Location *	LS
Category	Earthen Levee			GPS Latitude/Longitude	
				Start	End
Item	Animal Control			39.394010 °	39.394010 °
				-122.000977 °	-122.000977 °
DWR ID	DWR_LD0003_01_f_2015_52				
Comment Code					
A3 : No rodents visible, but rodent burrows visible; need to backfill and compact or grout burrows.					
Inspector Comment

View of the rodent holes along the landside slope.

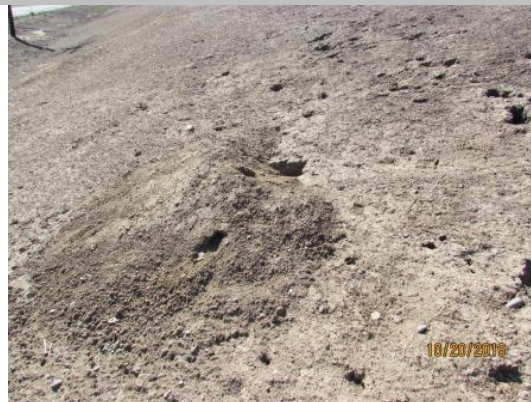
Photo 1 of 1 : SP_2017_LD0003_27_104_20170315_00058.jpg

View of the rodent holes along the landside slope.

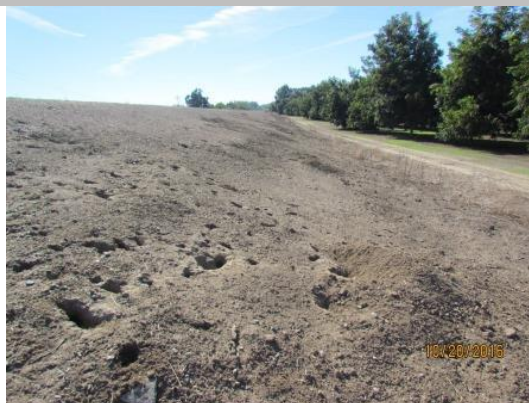
Photo 1 of 1 : SP_2017_LD0003_27_103_20170315_00057.jpg

View of the rodent holes along the waterside slope.

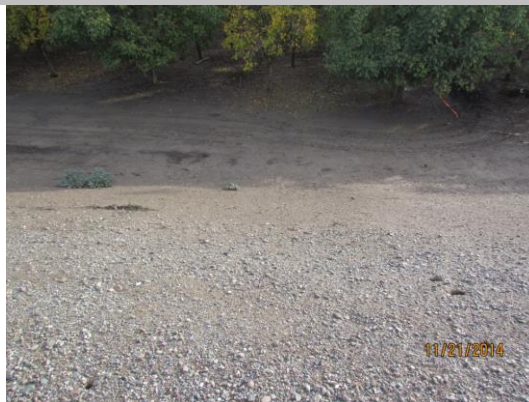
Photo 1 of 1 : SP_2017_LD0003_27_13_20170315_00011.jpg

LM Start	2.35	Rating **	M	Issue No.	13
LM End	2.52	Issue Type +	Ma	Location *	WS
Category	Earthen Levee			GPS Latitude/Longitude	
				Start	End
Item	Animal Control			39.406413 °	39.407248 °
				-121.995993 °	-121.993177 °
DWR ID	DWR_LD0003_01_s_2012_13				
Comment Code					
A3 : No rodents visible, but rodent burrows visible; need to backfill and compact or grout burrows.					
Inspector Comment

View of the rodent holes along the waterside slope.

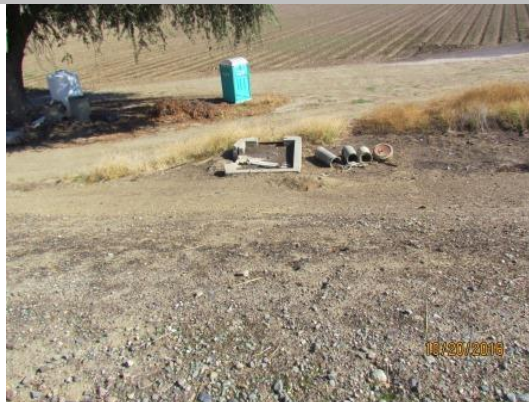
Photo 1 of 1 : SP_2017_LD0003_27_102_20170315_00056.jpg

LM Start	2.98	Rating **	M	Issue No.	102
LM End	2.98	Issue Type +	Ma	Location *	LS
Category	Earthen Levee			GPS Latitude/Longitude	
				Start	End
Item	Animal Control			39.412909 °	39.412909 °
				-121.991446 °	-121.991446 °
DWR ID	DWR_LD0003_01_f_2016_102				
Comment Code					
A1 : Exterminate rodents and backfill and compact or grout burrows.					
Inspector Comment

View of the rodent holes along the landside slope.

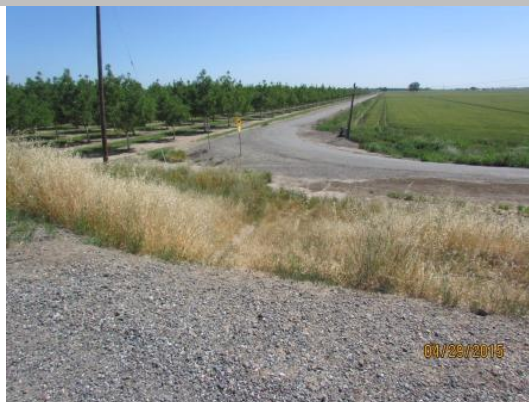
Photo 1 of 1 : SP_2017_LD0003_27_9_20170315_00006.jpg

LM Start	3.39	Rating **	M	Issue No.	9
LM End	3.39	Issue Type +	Ma	Location *	LS
Category	Earthen Levee			GPS Latitude/Longitude	
				Start	End
Item	Slope Stability			39.418382 °	39.418382 °
				-121.992480 °	-121.992480 °
DWR ID	DWR_LD0003_01_s_2012_9				
Comment Code					
S3 : Repair the levee slope damaged by vehicle traffic and prevent access where possible.					
Inspector Comment					
Repair the erosion along the landside slope and prevent vehicle access

View of the vehicle erosion along the landside slope.

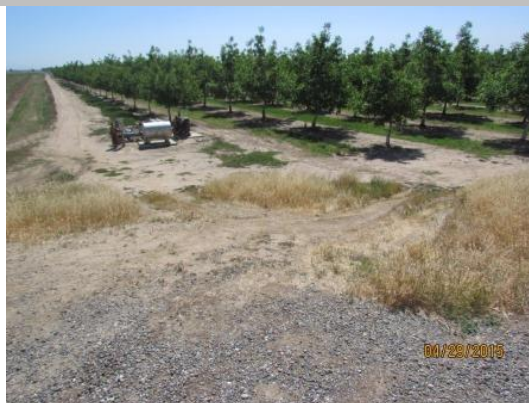
Photo 1 of 1 : SP_2017_LD0003_27_19_20170315_00013.jpg

LM Start	3.76	Rating **	M	Issue No.	19
LM End	3.76	Issue Type +	Ma	Location *	LS
Category	Earthen Levee			GPS Latitude/Longitude	
				Start	End
Item	Slope Stability			39.423747 °	39.423747 °
				-121.991667 °	-121.991667 °
DWR ID	DWR_LD0003_01_s_2012_19				
Comment Code					
S3 : Repair the levee slope damaged by vehicle traffic and prevent access where possible.					
Inspector Comment

View of the vehicle erosion along the landside slope.

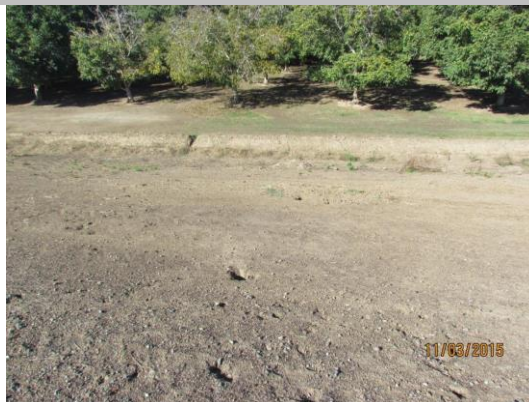
Photo 1 of 1 : SP_2017_LD0003_27_59_20170315_00031.jpg

LM Start	3.88	Rating **	M	Issue No.	59
LM End	3.88	Issue Type +	Ma	Location *	WS
Category	Earthen Levee			GPS Latitude/Longitude	
				Start	End
Item	Animal Control			39.425162 °	39.425162 °
				-121.990528 °	-121.990528 °
DWR ID	DWR_LD0003_01_f_2015_59				
Comment Code					
A3 : No rodents visible, but rodent burrows visible; need to backfill and compact or grout burrows.					
Inspector Comment

View of the rodent holes along the landside slope.

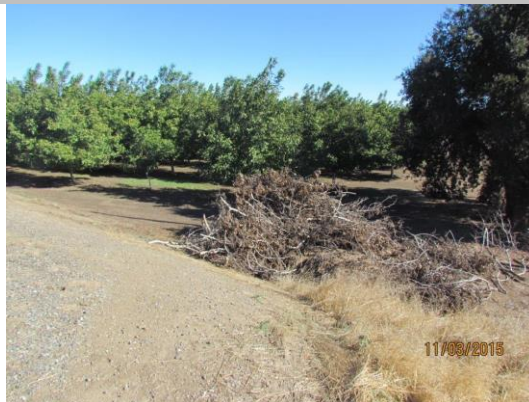
Photo 1 of 1 : SP_2017_LD0003_27_66_20170315_00038.jpg

LM Start	4.33	Rating **	M	Issue No.	66
LM End	4.33	Issue Type +	Ma	Location *	LS
Category	Earthen Levee			GPS Latitude/Longitude	
				Start	End
Item	Encroachments			39.430927 °	39.430927 °
				-121.987142 °	-121.987142 °
DWR ID	DWR_LD0003_01_f_2015_66				
Comment Code					
PR : Prunings					
Inspector Comment					
Remove the prunings from the landside slope.

View of the prunings along the landside toe.

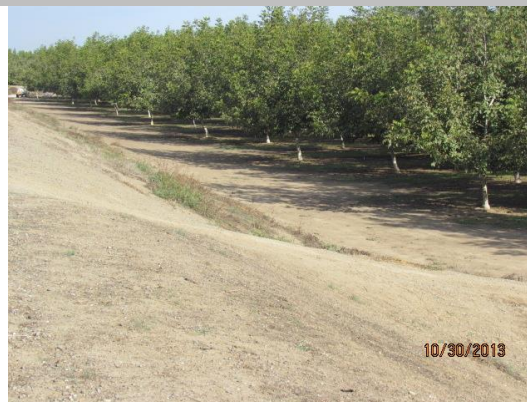
Photo 1 of 1 : SP_2017_LD0003_27_64_20170315_00036.jpg

View of the rodent activity along the landside slope.

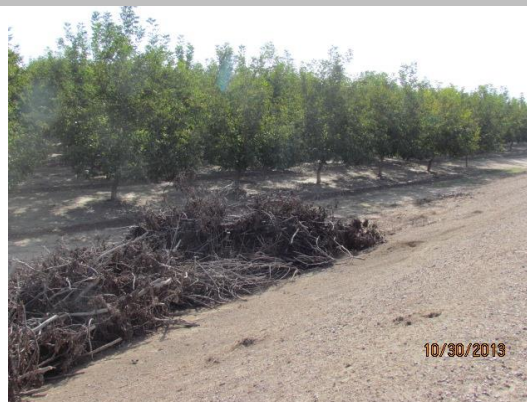
Photo 1 of 1 : SP_2017_LD0003_27_63_20170315_00035.jpg

LM Start	4.66	Rating **	M	Issue No.	63
LM End	4.66	Issue Type +	Ma	Location *	LS
Category	Earthen Levee			GPS Latitude/Longitude	
				Start	End
Item	Encroachments			39.435701 °	39.435701 °
				-121.988189 °	-121.988189 °
DWR ID	DWR_LD0003_01_f_2013_63				
Comment Code					
PR : Prunings					
Inspector Comment					
Remove the prunings from the landside toe.

View of the prunings along the landside toe.

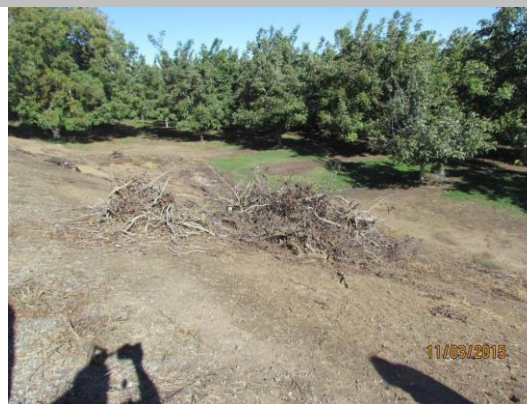
Photo 1 of 1 : SP_2017_LD0003_27_69_20170315_00040.jpg

View of the prunings along the landside slope.

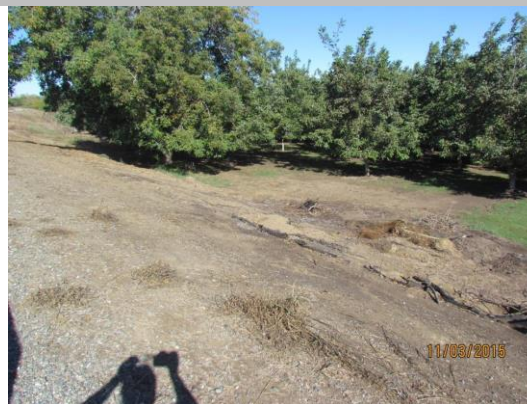
Photo 1 of 1 : SP_2017_LD0003_27_21_20170315_00014.jpg

LM Start	5.06	Rating **	U	Issue No.	21
LM End	5.25	Issue Type +	Ma	Location *	LS
Category	Earthen Levee			GPS Latitude/Longitude	
				Start	End
Item	Animal Control			39.441128 °	39.443793 °
				-121.990475 °	-121.991297 °
DWR ID	DWR_LD0003_01_f_2015_21				
Comment Code					
A3 : No rodents visible, but rodent burrows visible; need to backfill and compact or grout burrows.					
Inspector Comment

View of the rodent holes along the landside slope.

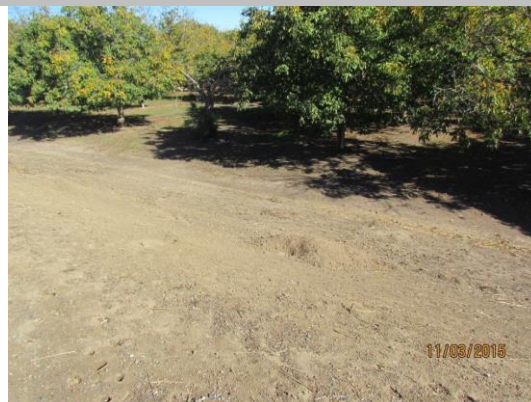
Photo 1 of 1 : SP_2017_LD0003_27_70_20170315_00041.jpg

View of the rodent holes along the landside slope.

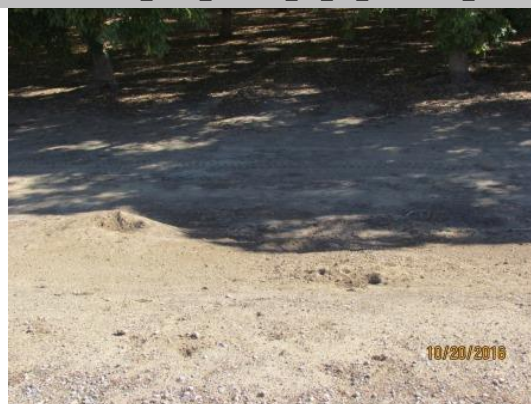
Photo 1 of 1 : SP_2017_LD0003_27_62_20170315_00034.jpg

LM Start	5.53	Rating **	U	Issue No.	62
LM End	5.62	Issue Type +	Ma	Location *	LS
Category	Earthen Levee			GPS Latitude/Longitude	
				Start	End
Item	Animal Control			39.447900 °	39.449115 °
				-121.991748 °	-121.991873 °
DWR ID	DWR_LD0003_01_f_ 2013_62				
Comment Code					
A3 : No rodents visible, but rodent burrows visible; need to backfill and compact or grout burrows.					
Inspector Comment

View of the rodent holes along the landside slope.

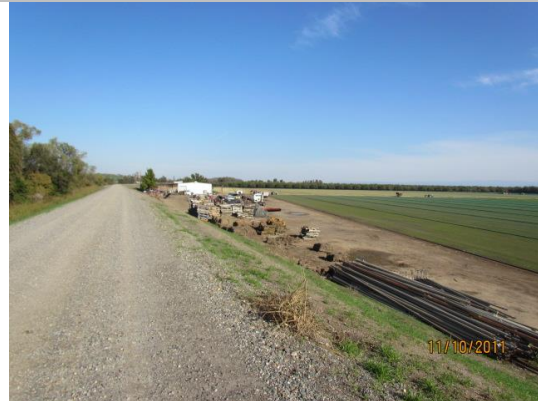
Photo 1 of 1 : SP_2017_LD0003_27_25_20170315_00015.jpg

View of the equipment along the landside toe.

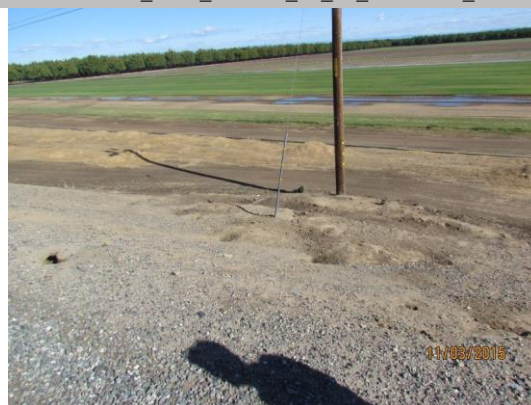
Photo 1 of 1 : SP_2017_LD0003_27_71_20170315_00042.jpg

View of the rodent holes along the landside slope.

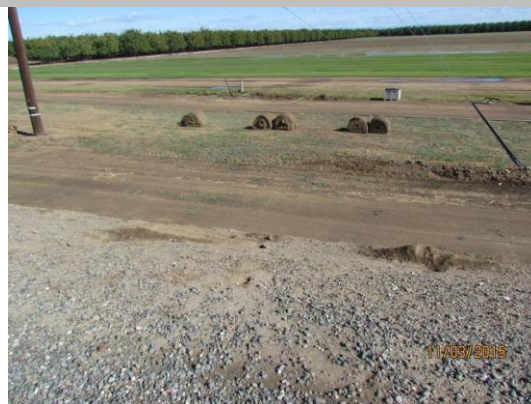
Photo 1 of 1 : SP_2017_LD0003_27_72_20170315_00043.jpg

LM Start	6.11	Rating **	U	Issue No.	72
LM End	6.11	Issue Type +	Ma	Location *	LS
Category	Earthen Levee			GPS Latitude/Longitude	
				Start	End
Item	Animal Control			39.456018 °	39.456018 °
				-121.993772 °	-121.993772 °
DWR ID	DWR_LD0003_01_f_2015_72				
Comment Code					
A3 : No rodents visible, but rodent burrows visible; need to backfill and compact or grout burrows.					
Inspector Comment

View of the rodent holes along the landside slope.

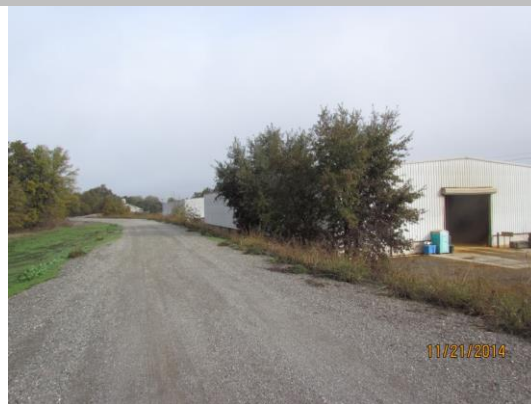
Photo 1 of 1 : SP_2017_LD0003_27_7_20170315_00005.jpg

LM Start	6.24	Rating **	M	Issue No.	7
LM End	6.38	Issue Type +	Ma	Location *	LS
Category	Earthen Levee			GPS Latitude/Longitude	
				Start	End
Item	Trim / Thin Trees			39.457968 °	39.459955 °
				-121.993712 °	-121.993512 °
DWR ID	DWR_LD0003_01_s_2012_7				
Comment Code					
T1 : Trim trees to at least five feet above ground level.					
Inspector Comment

Trim the trees 5 feet for better visibility.

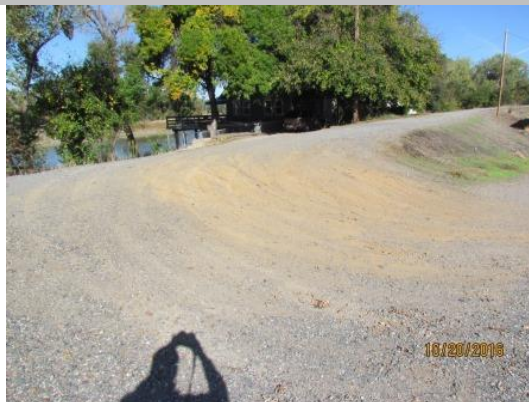
Photo 1 of 1 : SP_2017_LD0003_27_34_20170315_00018.jpg

LM Start	6.57	Rating **	M	Issue No.	34
LM End	6.57	Issue Type +	Ma	Location *	LS
Category	Earthen Levee			GPS Latitude/Longitude	
				Start	End
Item	Slope Stability			39.462505 °	39.462505 °
				-121.992698 °	-121.992698 °
DWR ID	DWR_LD0003_01_s_2012_34				
Comment Code					
S3 : Repair the levee slope damaged by vehicle traffic and prevent access where possible.					
Inspector Comment

View of slope instability caused by vehicle traffic.

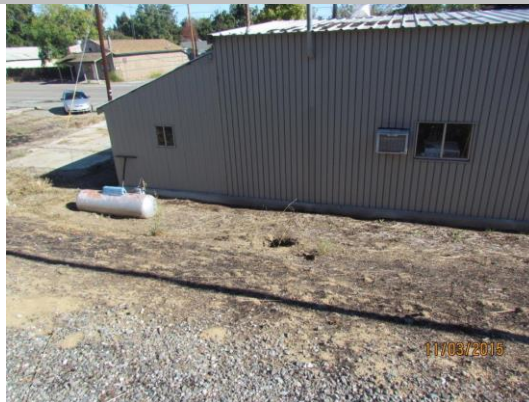
Photo 1 of 1 : SP_2017_LD0003_27_76_20170315_00045.jpg

LM Start	6.61	Rating **	U	Issue No.	76
LM End	6.61	Issue Type +	Ma	Location *	LS
Category	Earthen Levee			GPS Latitude/Longitude	
				Start	End
Item	Trim / Thin Trees			39.463185 °	39.463185 °
				-121.992657 °	-121.992657 °
DWR ID	DWR_LD0003_01_f_2015_76				
Comment Code					
T5 : Tree stumps.					
Inspector Comment					
Repair the burned out stump hole along the landside toe.

View of the burned out stump hole along the landside toe.

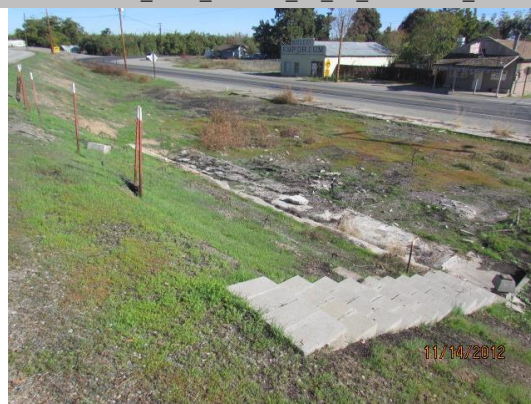
Photo 1 of 1 : SP_2017_LD0003_27_12_20170315_00010.jpg

LM Start	6.63	Rating **	M	Issue No.	12
LM End	6.63	Issue Type +	Ma	Location *	LS
Category	Earthen Levee			GPS Latitude/Longitude	
				Start	End
Item	Slope Stability			39.463366 °	39.463366 °
				-121.992586 °	-121.992586 °
DWR ID	DWR_LD0003_01_f_2012_12				
Comment Code					
S1 : Repair slope instability.					
Inspector Comment					
Building has burned down.

View of concrete stairs & foundation along the slope of the levee.

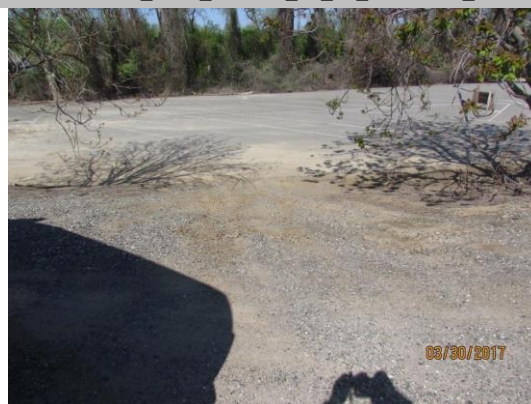
Photo 1 of 1 : SP_2017_LD0003_27_97_20170330_00102.jpg

LM Start	6.72	Rating **	M	Issue No.	97
LM End	6.72	Issue Type +	Ma	Location *	WS
Category	Earthen Levee			GPS Latitude/Longitude	
				Start	End
Item	Slope Stability			39.464653 °	39.464653 °
				-121.991789 °	-121.991789 °
DWR ID	DWR_LD0003_01_f_2016_97				
Comment Code					
S3 : Repair the levee slope damaged by vehicle traffic and prevent access where possible.					
Inspector Comment					
Repair the vehicle ruts on the waterside slope.

View of the vehicle ruts on the waterside slope.

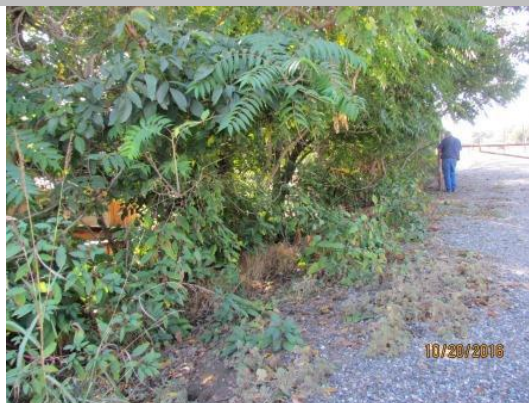
Photo 1 of 1 : SP_2017_LD0003_27_35_20170315_00019.jpg

View of the trees that are hanging over the landside slope of the levee.

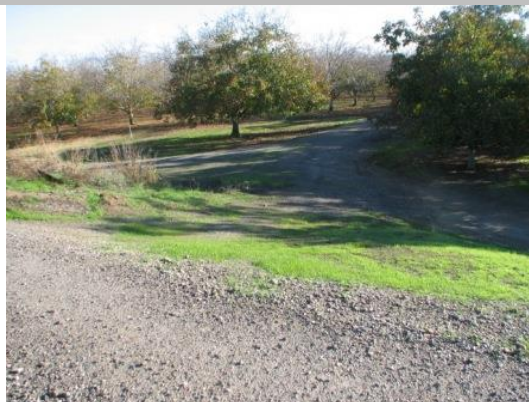
Photo 1 of 1 : SP_2017_LD0003_27_14_20170315_00012.jpg

LM Start	7.21	Rating **	M	Issue No.	14
LM End	7.21	Issue Type +	Ma	Location *	LS
Category	Earthen Levee			GPS Latitude/Longitude	
				Start	End
Item	Slope Stability			39.471658 °	39.471658 °
				-121.991245 °	-121.991245 °
DWR ID	DWR_LD0003_01_s_2012_14				
Comment Code					
S3 : Repair the levee slope damaged by vehicle traffic and prevent access where possible.					
Inspector Comment

View of the vehicle erosion along the landside slope.

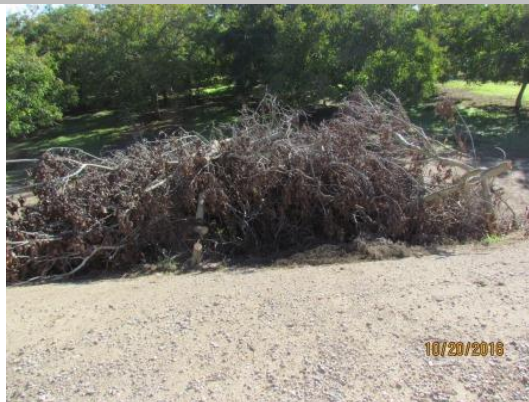
Photo 1 of 1 : SP_2017_LD0003_27_60_20170315_00032.jpg

View of the prunings along the landside toe.

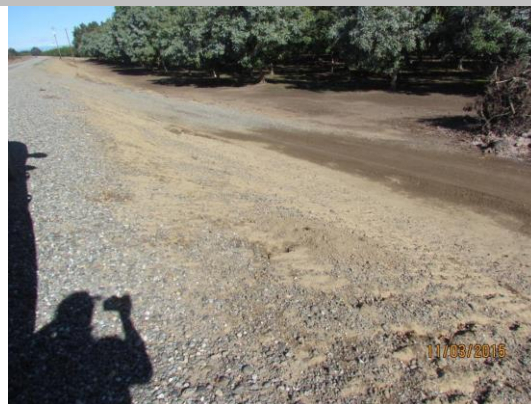
Photo 1 of 1 : SP_2017_LD0003_27_78_20170315_00047.jpg

View of the rodent holes along the landside slope.

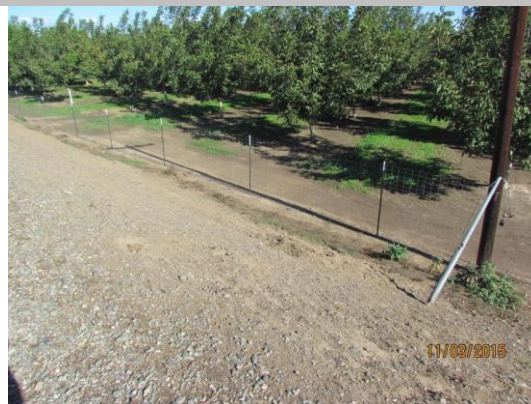
Photo 1 of 1 : SP_2017_LD0003_27_79_20170315_00048.jpg

View of the rodent holes along the landside slope.

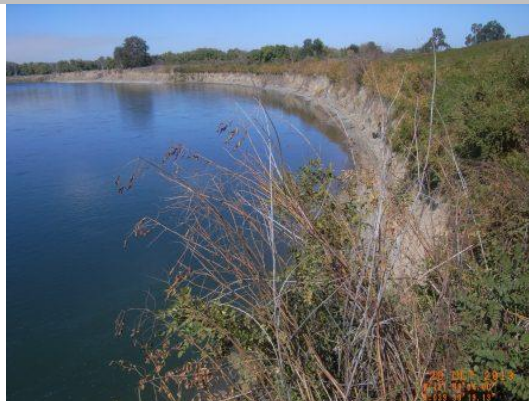
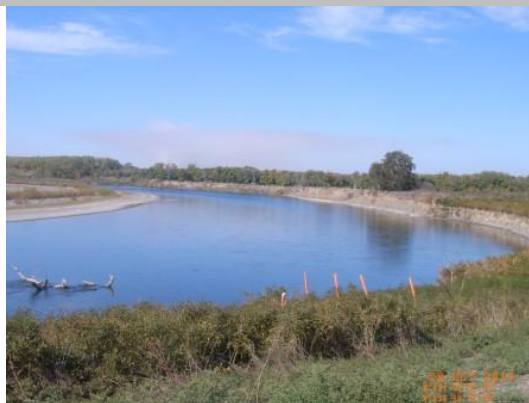
Comment Code					
Inspector Comment					
2007 - Getting close to the levee. Bank is clayey silt with clayey/silty toe. 2008 - Looks a little worse at the upstream end. 2009 - Some new erosion and slumping. 2010 - Some new erosion upstream of site, actively eroding at low flow. New bank swallow colony noted. 2011 - Significant erosion since last year, with an estimated 10 to 15 feet of berm lost. Large sections of the bank have slumped off. 2012 - Part of the site appears to be stabilizing, but still minor slumping in other locations. 2013 - Minor new erosion at toe. 2015: Last observed in 2013. [2015 Site ID: SAC_172-0_L] On 3/25/2016, recent high water caused river to erode to within 10-20 feet of levee toe. Appears still somewhat active.

USACE 2013 Photo #1

USACE 2013 Photo #2

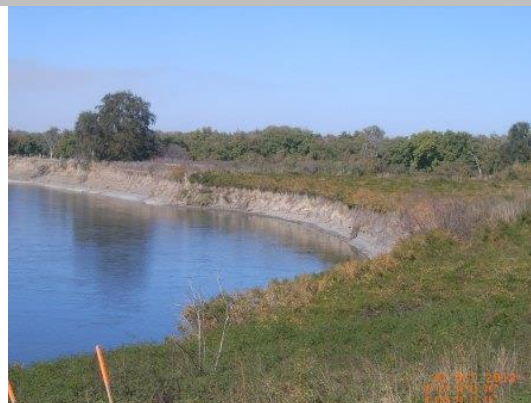
Photo 3 of 3 : SP_2017_LD0003_27_10_20170315_00009.jpg

Comment Code					
Inspector Comment					
2007 - Getting close to the levee. Bank is clayey silt with clayey/silty toe. 2008 - Looks a little worse at the upstream end. 2009 - Some new erosion and slumping. 2010 - Some new erosion upstream of site, actively eroding at low flow. New bank swallow colony noted. 2011 - Significant erosion since last year, with an estimated 10 to 15 feet of berm lost. Large sections of the bank have slumped off. 2012 - Part of the site appears to be stabilizing, but still minor slumping in other locations. 2013 - Minor new erosion at toe. 2015: Last observed in 2013. [2015 Site ID: SAC_172-0_L] On 3/25/2016, recent high water caused river to erode to within 10-20 feet of levee toe. Appears still somewhat active.

USACE 2013 Photo #3

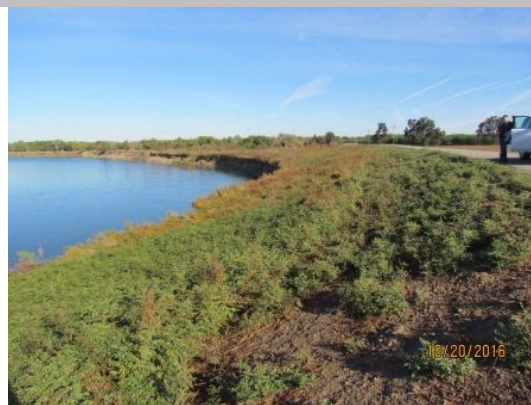
Photo 1 of 6 : SP_2017_LD0003_27_50_20170315_00023.jpg

LM Start	9.70	Rating **	U	Issue No.	50
LM End	9.70	Issue Type +	Ma	Location *	WS
Category	Earthen Levee			GPS Latitude/Longitude	
				Start	End
Item	Erosion / Bank Caving			39.505435 °	39.505435 °
				-121.984172 °	-121.984172 °
DWR ID	DWR_LD0003_01_f_2014_50				
Comment Code					
E2 : Schedule repair of erosion site prior to the next inspection.					
Inspector Comment					
Repair the erosion along the waterside toe. On 3/25/2016, recent high water caused river to erode to within 10-20 feet of levee toe. Appears still somewhat active.

View of the erosion along the waterside toe. Same site as the USACE erosion issue. Photo: 10/20/2016

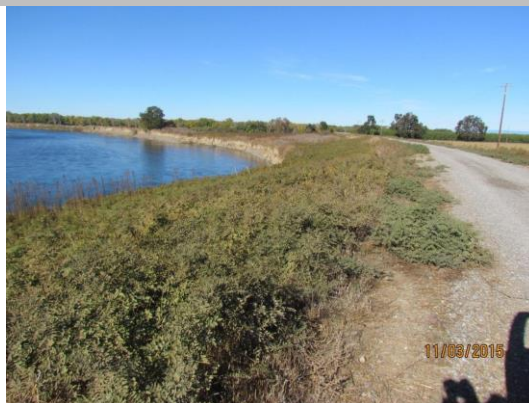
Photo 2 of 6 : SP_2017_LD0003_27_50_20170315_00024.jpg

LM Start	9.70	Rating **	U	Issue No.	50 (cont)	
LM End	9.70	Issue Type +	Ma	Location *	WS	
Category	Earthen Levee			GPS Latitude/Longitude		
				Start		End
Item	Erosion / Bank Caving			39.505435 °		39.505435 °
				-121.984172 °		-121.984172 °
DWR ID	DWR_LD0003_01_f_2014_50					
Comment Code						
E2 : Schedule repair of erosion site prior to the next inspection.						
Inspector Comment						
Repair the erosion along the waterside toe. On 3/25/2016, recent high water caused river to erode to within 10-20 feet of levee toe. Appears still somewhat active.

View of the erosion along the waterside toe. Same site as the USACE erosion issue.

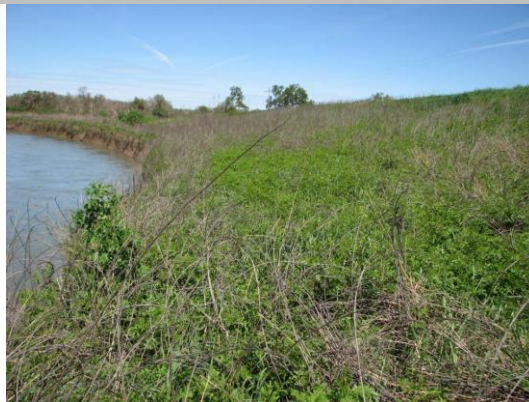
Photo 3 of 6 : SP_2017_LD0003_27_50_20170315_00025.jpg

View of erosion along the waterside toe. Same site as the USACE erosion issue. Photo 3/25/2016

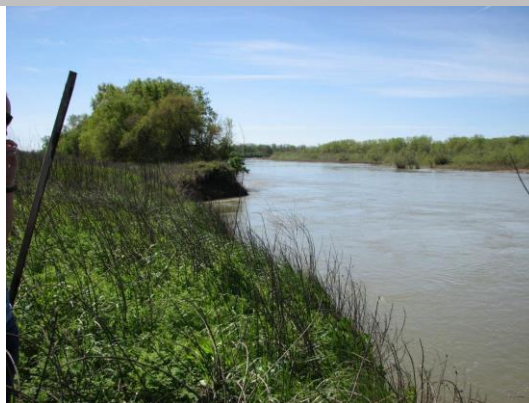
Photo 4 of 6 : SP_2017_LD0003_27_50_20170315_00026.jpg

LM Start	9.70	Rating **	U	Issue No.	50 (cont)	
LM End	9.70	Issue Type +	Ma	Location *	WS	
Category	Earthen Levee			GPS Latitude/Longitude		
				Start		End
Item	Erosion / Bank Caving			39.505435 °		39.505435 °
				-121.984172 °		-121.984172 °
DWR ID	DWR_LD0003_01_f_2014_50					
Comment Code						
E2 : Schedule repair of erosion site prior to the next inspection.						
Inspector Comment						
Repair the erosion along the waterside toe. On 3/25/2016, recent high water caused river to erode to within 10-20 feet of levee toe. Appears still somewhat active.

View of erosion along the waterside toe, downstream. Same site as the USACE erosion issue. Photo 3/25/2016

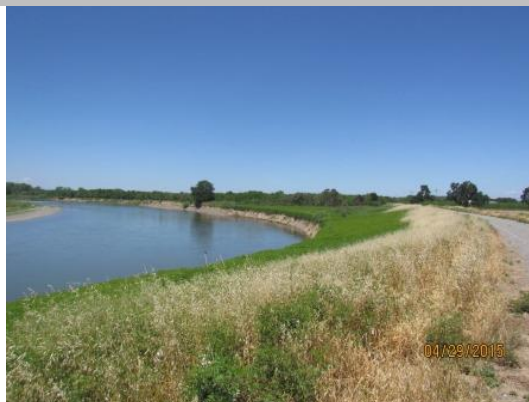
Photo 5 of 6 : SP_2017_LD0003_27_50_20170315_00027.jpg

View of erosion along the waterside toe. Same site as the USACE erosion issue.

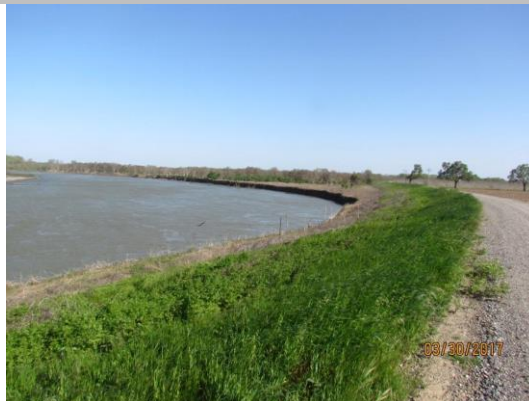
Photo 6 of 6 : SP_2017_LD0003_27_50_20170330_00106.jpg

LM Start	9.70	Rating **	U	Issue No.	50 (cont)	
LM End	9.70	Issue Type +	Ma	Location *	WS	
Category	Earthen Levee			GPS Latitude/Longitude		
				Start		End
Item	Erosion / Bank Caving			39.505435 °		39.505435 °
				-121.984172 °		-121.984172 °
DWR ID	DWR_LD0003_01_f_2014_50					
Comment Code						
E2 : Schedule repair of erosion site prior to the next inspection.						
Inspector Comment						
Repair the erosion along the waterside toe. On 3/25/2016, recent high water caused river to erode to within 10-20 feet of levee toe. Appears still somewhat active.

View of the erosion along the waterside toe. Same site as the USACE erosion issue.

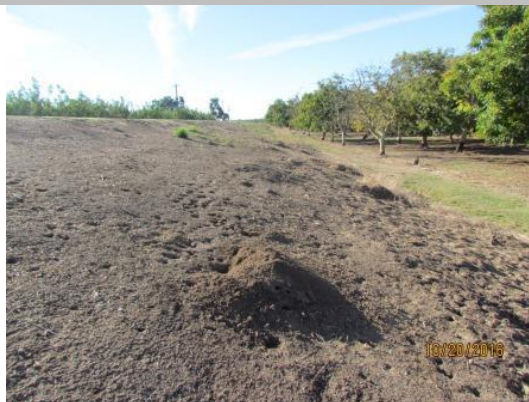
Photo 1 of 1 : SP_2017_LD0003_27_93_20170315_00051.jpg

View of the rodent holes along the waterside slope.

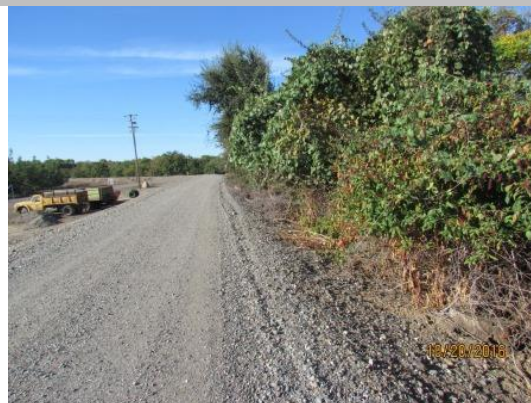
Photo 1 of 1 : SP_2017_LD0003_27_5_20170315_00003.jpg

View of the dense vegetation along the waterside slope.

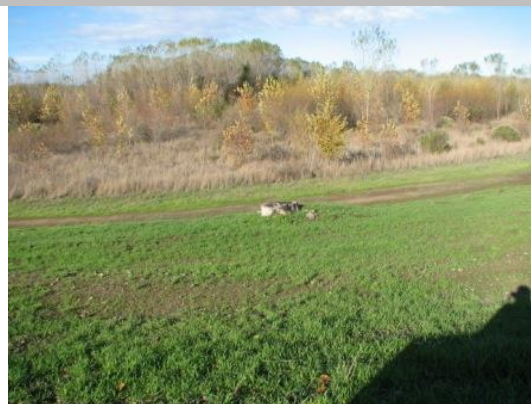
Photo 1 of 1 : SP_2017_LD0003_27_29_20170315_00016.jpg

View of the stump along the toe.

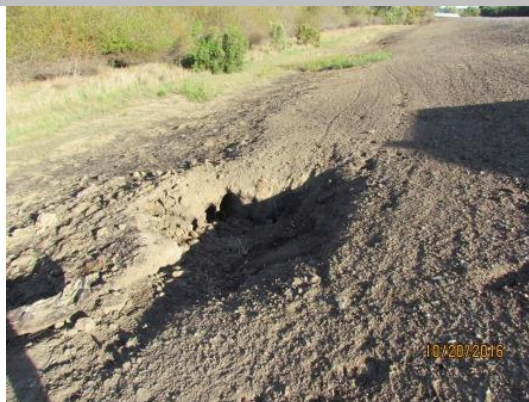
Photo 1 of 1 : SP_2017_LD0003_27_89_20170315_00049.jpg

LM Start	10.66	Rating **	U	Issue No.	89
LM End	10.66	Issue Type +	Ma	Location *	WS
Category	Earthen Levee			GPS Latitude/Longitude	
				Start	End
Item	Slope Stability			39.517553 °	39.517553 °
				-121.979132 °	-121.979132 °
DWR ID	DWR_LD0003_01_f_2016_89				
Comment Code					
S1 : Repair slope instability.					
Inspector Comment

View of a hole along the waterside slope that need to be backfilled and compacted.

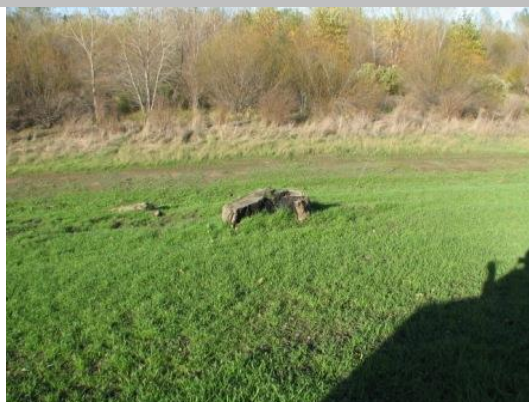
Photo 1 of 1 : SP_2017_LD0003_27_30_20170315_00017.jpg

View of the stump along the slope.

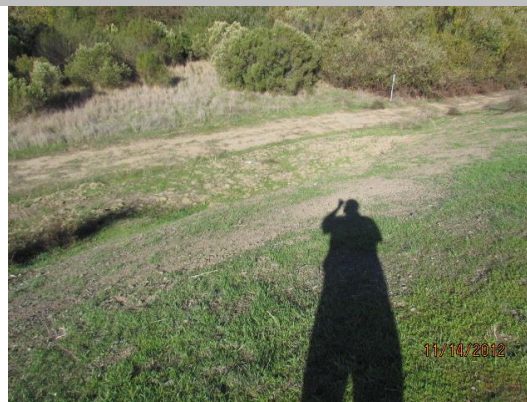
Photo 1 of 1 : SP_2017_LD0003_27_6_20170315_00004.jpg

LM Start	11.04	Rating **	M	Issue No.	6
LM End	11.04	Issue Type +	Ma	Location *	WS
Category	Earthen Levee			GPS Latitude/Longitude	
				Start	End
Item	Slope Stability			39.522921 °	39.522921 °
				-121.979172 °	-121.979172 °
DWR ID	DWR_LD0003_01_f_2012_6				
Comment Code					
S1 : Repair slope instability.					
Inspector Comment

View of the vertical cut along the waterside toe.
